Performance of insulation materials for historic buildings: case-studies comparing super insulation materials and hemp-lime

Performance of insulation materials for historic buildings

Case studies comparing a super insulation material and hemp-lime

P. Johansson¹, A. Donarelli², P. Strandberg³

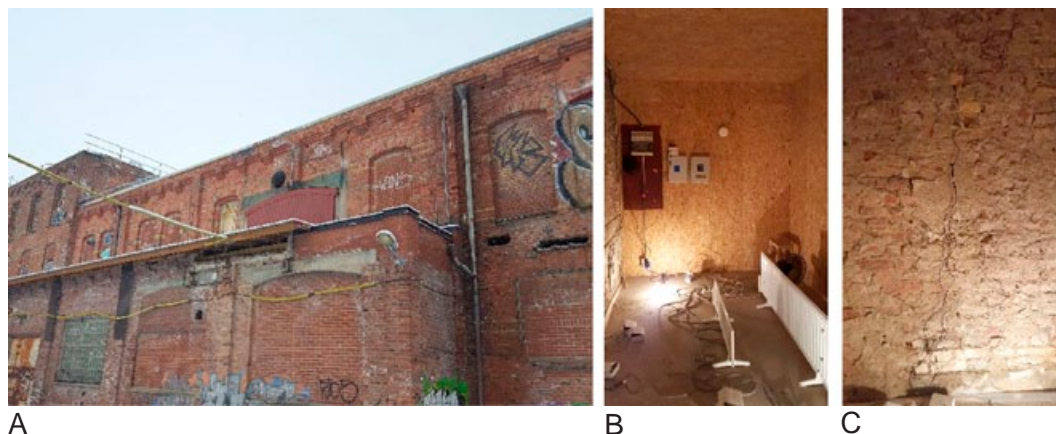
Figure 3. A) Industrial building from 1896 south of Gothenburg to be insulated on the interior with VIP, B) The test room inside the industrial building, C) Sensors in the external brick wall. Photos: Pär Johansson.

An old industrial brick building, see Figure 3, south of Gothenburg is planned to be equipped with VIP on the interior of the wall during 2018. The walls are made of 500 mm thick non-insulated homogenous brick masonry which gives a calculated U-value of $1.0 \text{ W/m}^2\text{K}$. The building was constructed in 1896 and has been reconstructed several times since then.

There are several challenges to renovate the building where the thermal performance of the walls is one example. The cultural values of the building have been evaluated and one of the features that is considered important is the brick façade. Therefore, interior insulation is considered to be a possible solution to reach sufficient energy performance [19]. Inside a part of the deserted building, a small room ($2.1 \times 2.6 \times 4.0 \text{ m}$) has been constructed which consist of floor, walls and roof insulated with 170 mm mineral wool, and the exposed brick wall, see Figure 3. The room is heated to around $22 \text{ }^{\circ}\text{C}$ and ventilated by natural ventilation with 0.5 h^{-1} air exchange rate. The air in the room is circulated by a fan to create homogenous temperature and moisture conditions in the entire room. The exterior wall is divided in three parts where VIP will be tested and compared to a non-insulated reference. The wall is equipped with hygrothermal sensors that every hour registers the temperature and relative humidity in the middle of the wall and at the interior surface. A weather station monitors the outdoor temperature, relative humidity, wind speed and rain intensity.
